TO: Director, National Institute for Occupational Safety and Health

FROM: California Fatality Assessment and Control Evaluation (FACE) Program

SUBJECT: An apprentice mechanic died when crushed in a machine that stacks wooden pallets.

SUMMARY
California FACE Report #03CA003

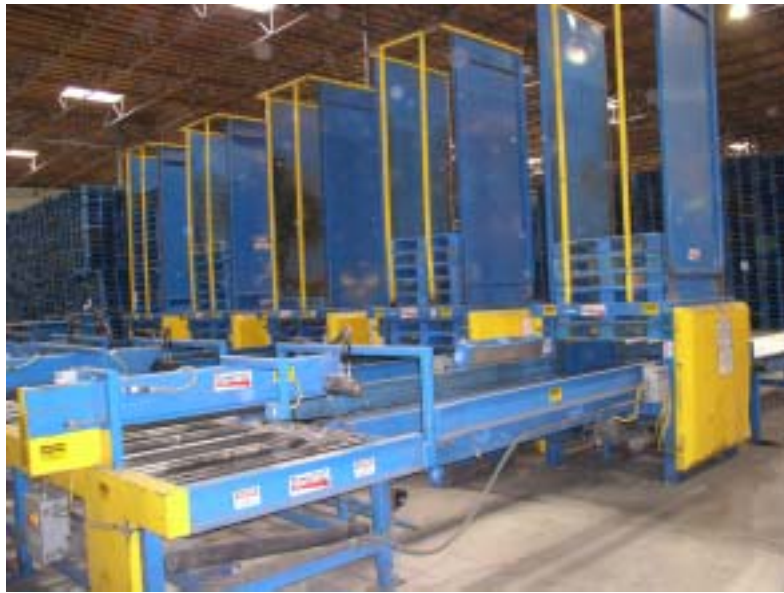
Exhibit #1

On March 17, 2003, at approximately 8:00 p.m., a 44-year-old apprentice mechanic was killed when he got caught in the hydraulic mechanism of a pallet stacking machine (**exhibit #1**). The CA/FACE investigator learned of this incident on March 27, 2003, through the Legal Unit of the Division of Occupational Safety and Health (Cal/OSHA). On April 23, 2003, the CA/FACE investigator traveled to the victim's place of employment where he interviewed company personnel and employees who responded to the incident. The investigator also inspected the incident site and took pictures of the machine involved in the incident.

View of the pallet stackers from the front or loading end.

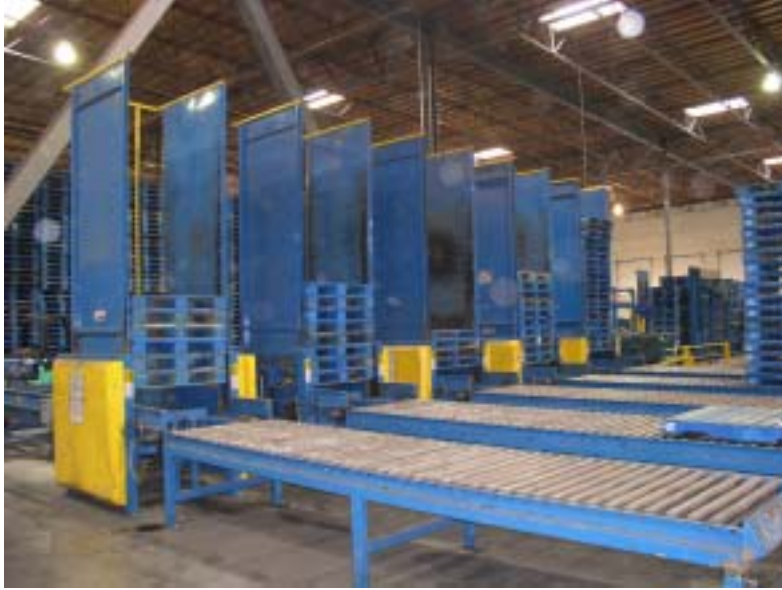
Exhibit #2

The site of the incident was a warehouse complex. The facility within the complex where the incident occurred manufactured, inspected, repaired, and distributed wooden pallets. It used a high-speed pallet sorting and stacking machine for this process. The fully automated system took the sorted pallets off a roller conveyor and stacked them to a designated number (1-20) (**exhibit #1**). The automated system was controlled through a series of electric eye sensors. When the pallet passed the first sensor, the automatic device used to pull the pallet into place was activated. When the pallet was pulled in place, another sensor was activated to start the stacking cycle. The hydraulic stacker lifted the pallet onto lifting dogs, and then went back down completing the cycle (**exhibit #4**). Lifting dogs are mechanical holding devices that grasp an object (usually on its edge) and hold it in place. A chain mechanism took the pallet into the stacking mechanism and passed another sensor, which counted the number of pallets stacked. When the desired number of pallets was reached, the machine ejected the stack onto the outgoing roller conveyor for removal and storage or shipping (**exhibit #2**).

View of the pallet stackers from the rear or unloading end.

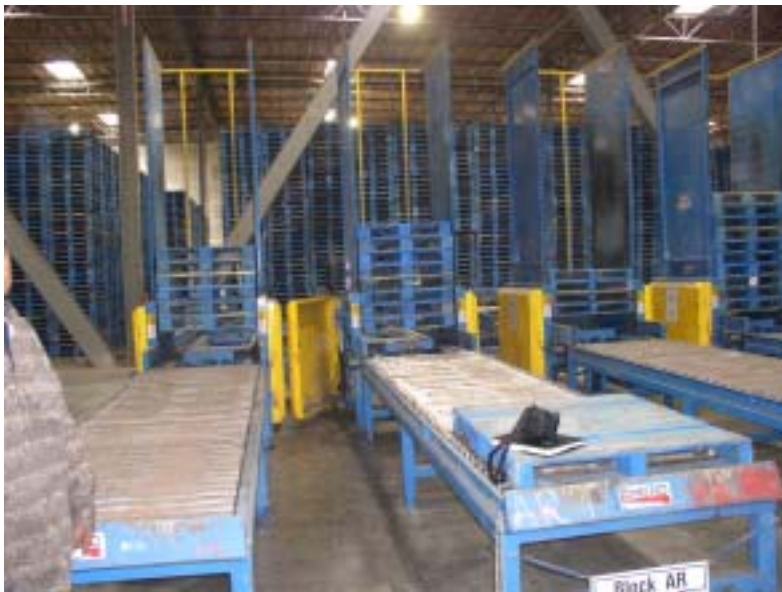
Exhibit #3

View of the pallet stacker involved in the incident.

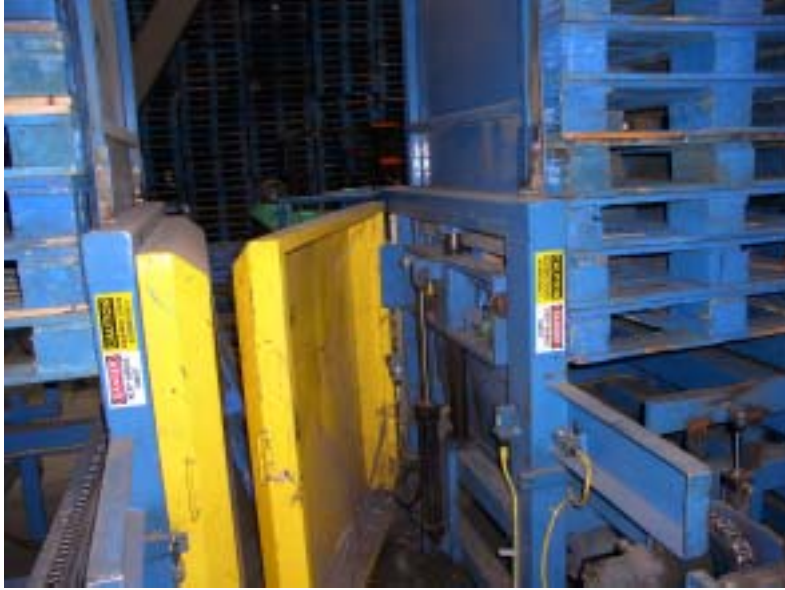
Exhibit #4

View of the hydraulic mechanism and electronic eyes used in the stacking process.

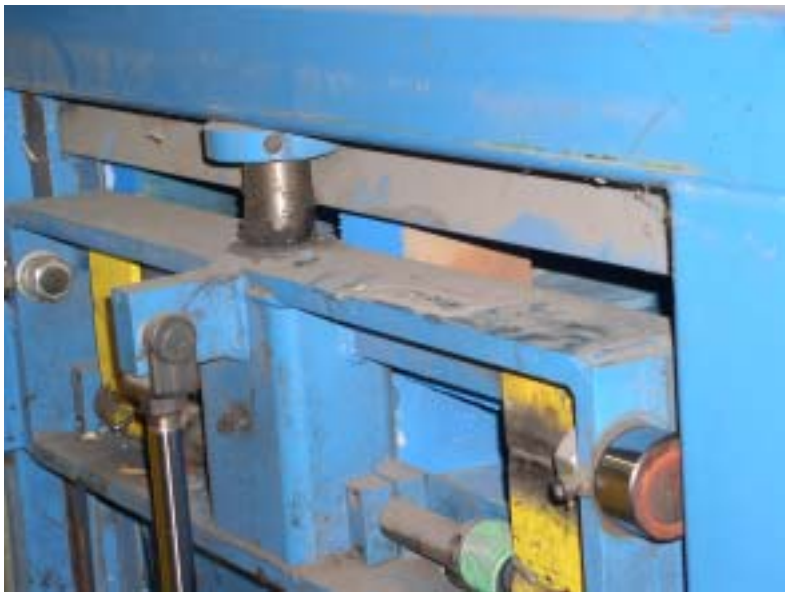
Exhibit #5

On the day of the incident, the victim was performing maintenance on the pallet stacker adjusting the hydraulic stacker mechanism. Access to the lifting mechanism was obtained by opening the guard or door protecting the device. The machine was not locked or tagged out before the victim put his head and chest between the hydraulic ram and the frame of the machine. Evidence suggests the victim completed his adjustment and was reaching inside the mechanism to pick up a wrench he dropped on the floor. While the victim was in this position, he broke the beam that started the machine cycle. When the machine cycled, the victim was unable to get out in time. The journeyman mechanic in charge of the victim came around to check on his progress and saw that he was caught in the machine. He immediately shut off the power and cut the hydraulic lines in order to release the pressure and free the victim. Paramedics responded after being called and treated the victim, then transported him to a local hospital where death was pronounced.

A view of the hydraulic mechanism that crushed the victim.

Recommendation #1: Ensure that the lockout / tagout procedure is implemented whenever maintenance or repair is being performed on pallet stacking machines.

Discussion: The purpose behind a lockout / tagout procedure is to release any stored energy within a machine, then lock that source out while the machine is being worked on to protect the worker. It also prevents accidental starting of a machine while it is being worked on. A lockout / tagout program with an energy control procedure specific to the equipment involved might have prevented this incident. Even the company's generic lockout/tagout program, had it been implemented, might have prevented this incident.

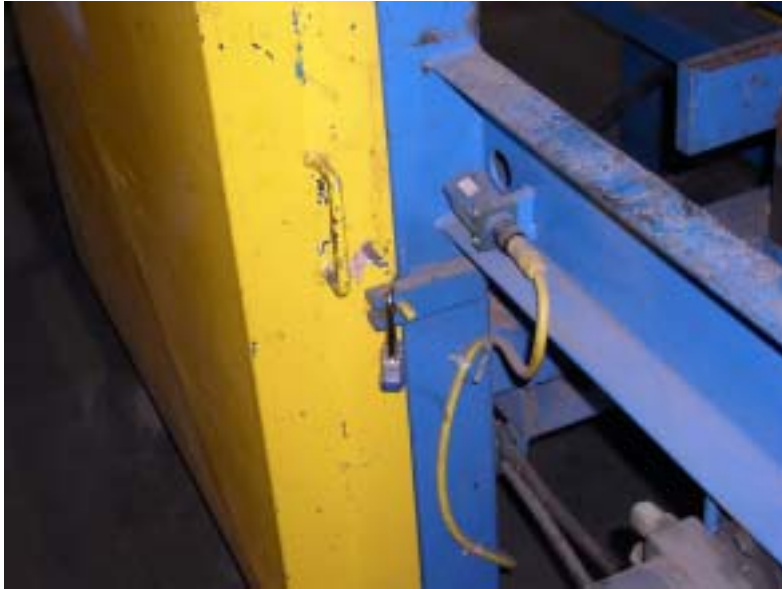
Exhibit #6

A view of the electronic eye sensor that activates the hydraulic mechanism.
